THE WHITE PINE ROUTE QUARTERLY

The Journal of the Washington, Idaho & Montana Ry. History Preservation Group, Inc.

Washout! - *The WI&M Rebounds From a Rough Day at Yale*

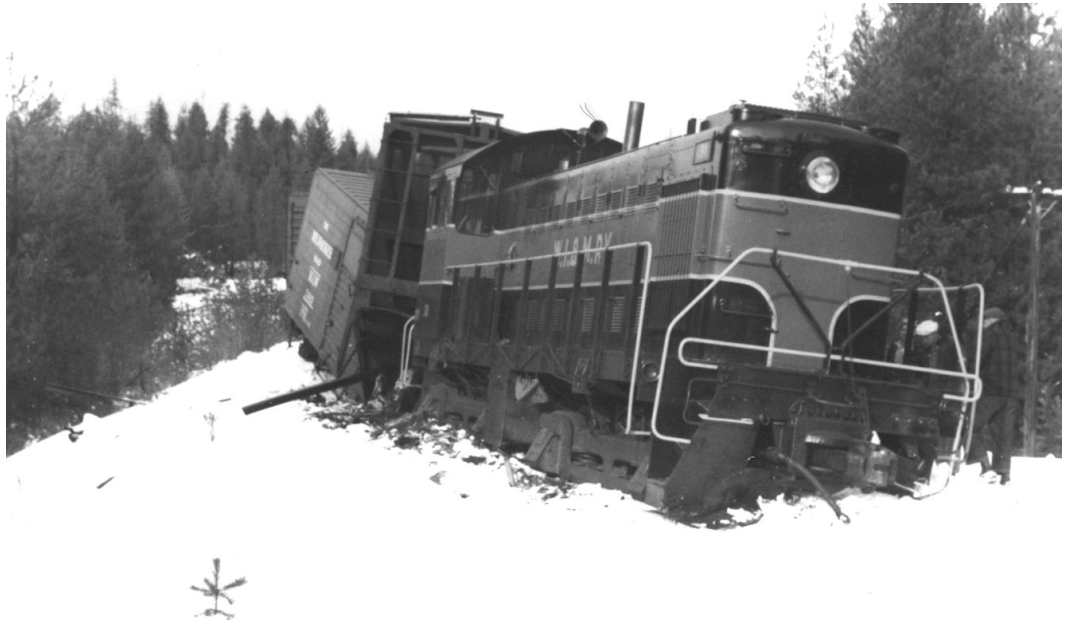
WI&M locomotive #30 has sunk to its axles in muddy snow after a fill washed out under the weight of its train in February, 1965. Photo: University of Idaho Special Collections Library

At this location, the railroad ran on a raised fill across the north end of a small meadow. On the opposite side of the tracks a narrow trench dropped down and away from the meadow. Recognizing that moisture collecting in the meadow would naturally drain along this trench, the WI&M's builders had wisely placed a 4-foot square wooden culvert under the fill to ensure that water would continue its normal flow unimpeded. Over time, however, the culvert had become clogged, turning the fill into a dam. As the snow covering the meadow began to melt, the pressure against the south side of the fill increased. And, with the water fully saturating the fill material, conditions became ripe for a washout.
